21154 PCI-to-PCI Bridge

Specification Update

July 2004

Order Number: [278295-017](#)

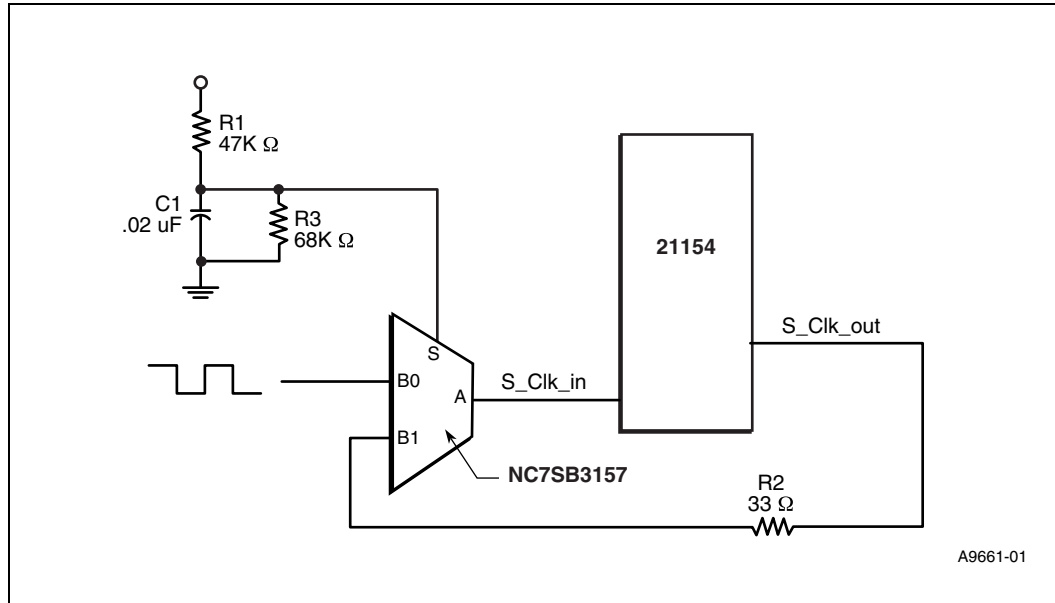
Figure 1. S_Clock Multiplexer Workaround Circuit for Errata 6.

6. Secondary Clocks Outputs s_clk_o<9:0> May Not Start-up Properly Under Some Conditions

Problem: This problem has been found on the 21154AC and 21154BC. Under repeated and frequent power cycling, the secondary clock circuits may not power up in the proper state, resulting in the device not coming out of reset after power up.

Implication: In a system with a 21154AC or 21154BC that has one of its s_clk_o<9:0> outputs fed back to provide the s_clk, it is possible that the s_clk_o<9:0> output clocks will be driven and remain low, keeping s_rst_l asserted, during system power up.

This happens occasionally when a latch whose output disables the serial shift registers on the Secondary clock control powers up in a high state and the shift register bit corresponding to the s_clk_o<9:0> output that is fed back also powers up in the high state.

1. [Figure 1](#) illustrates the first recommendation - a circuit where an on-board pulse source is gated via the B0 input of the multiplexer to the S_Clock_in pin of the 21150.

At time 0, the S input of the multiplexer is low, allowing pulses from the on-board pulse source, connected to the B0 input, to be provided to the 21150 S_Clk input pin. When the time determined by the R/C network is satisfied, the S input pin will be in a logic High state. The multiplexer will then shut off the input pulse from S0 and will direct the S_Clock_out pulses via the B1 multiplexer input, into S_Clock_in

The values used for the R/C network should be selected to allow a minimum of 2 pulses to be delivered to the 21150 after Vdd has reached 3.0V at a frequency not to exceed the appropriate PCI component. i.e. 30 ns for a 33Mhz bridge. These values should be chosen based on the rise time of the power supply and the frequency of the on board pulse source. The values given for R1, R3, and C1 are for example purposes only.

Note: The NC7SB3157 2:1 Multiplexer / Demultiplexer Bus Switch used in this example has a maximum propagation delay of 800ps that should be taken into consideration when matching trace lengths of the clock lines to avoid introducing excessive skew in the clocks. All S_Clock etch lengths must be matched to within 2ns @ 33Mhz or 1ns @ 66Mhz. The addition of this circuit requires that the etch length for the S_clock_in signal be reduced to compensate for the 800ps delay.

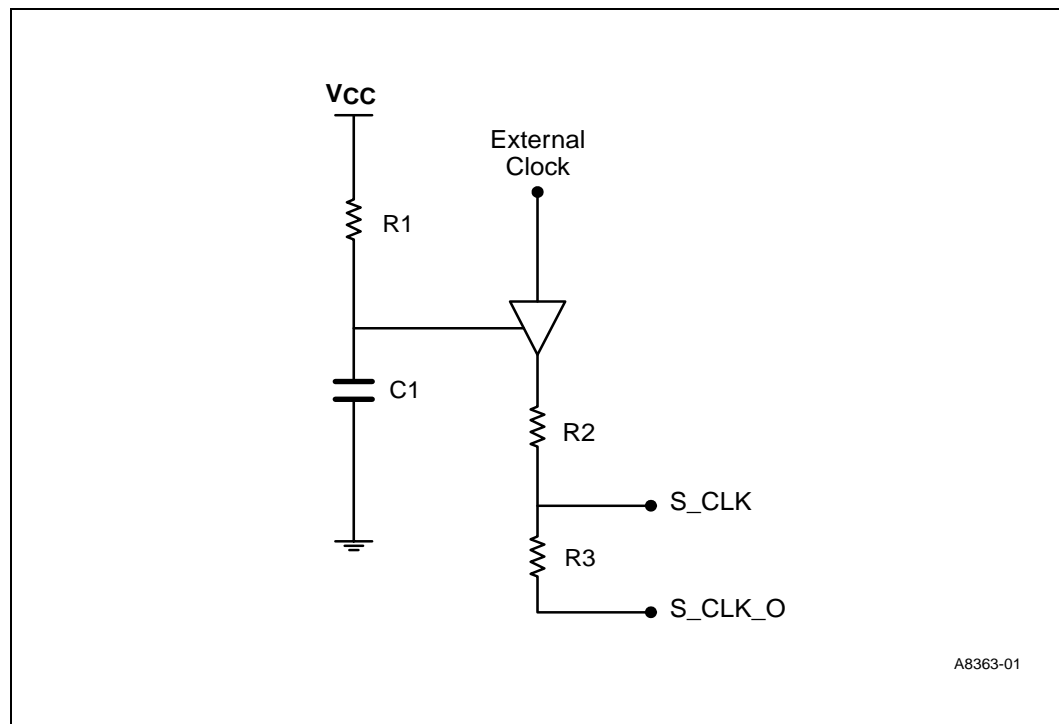
Figure 2. Recommended Circuit for a Tristable Buffer

2. In the second recommendation, to guarantee the proper initialization of the **s_clk** circuits, the addition of an external circuit that provides a minimum of two transitions on the **s_clk** input during the power-up ramp is necessary. This can be done using a solution that drives an external clock onto the **s_clk** input while 3.3V Vcc is ramping during power up.

Figure 2 illustrates the use of a tristable buffer to provide multiple pulses to the **s_clk** input. The Vcc ramp rate and R1,C1 time constant determine the duration and amplitude of the pulses generated during power up. The R2-R3 values are chosen based on applicable board etch impedance-matching requirements.

The following should be considered in calculating the R1,C1 time constant:

- Make the time constant of the circuit as short as possible, while still ensuring that a minimum of two pulses are generated during the Vcc ramp.
- Phase delay between **s_clk_o** and the external clock should be minimized.
- Matching the external clock and **s_clk_o** frequencies to reduce contention.
- Laboratory experiments using **p_clk** as the external clock and a R1C1 time constant between 40 and 60 percent of the Vcc ramp have been successful using this configuration. However the use of **p_clk** as the external clock violates the PCI bus specification for loading of the primary clock.

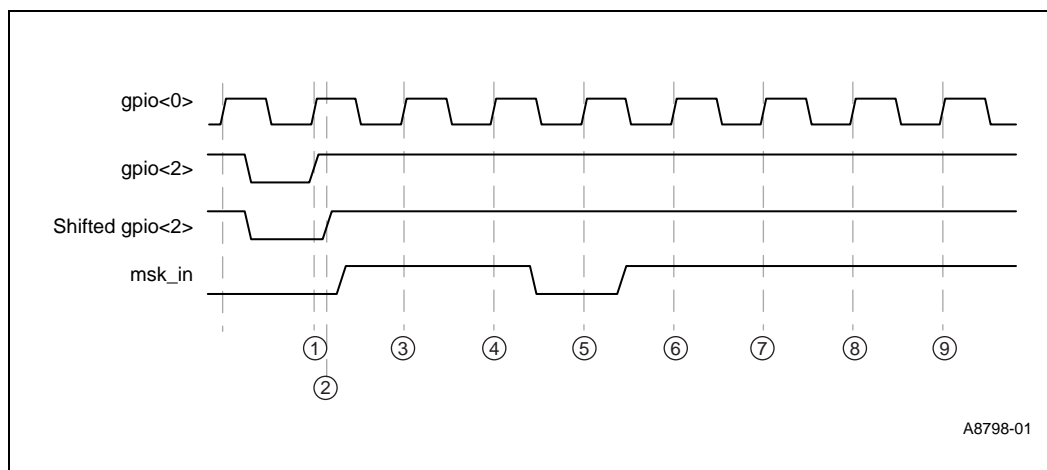
Figure 21. Clock Mask and Load Shift Timing

1. The **gpio<2>** original coming from the 21154 does not provide 3ns setup time needed to provide the parallel load enable **PE#** of the 74F166.
2. The shifted **gpio<2>** is delayed by ~9ns to provide ample setup time to enable the parallel of the shift register connected to pin 15 of the 74F166.
3. Bit 15 input **D6** of the shift register is pulled high, to Vcc.
4. Bit 14 input **D7** is pulled high, to Vcc. These signals are not used internally in the 21154.
5. Bit 13 **s_clk_o<9>** is a feedback to the 21154 **s_clk_o** input. To enable **s_clk_o<9>** in all cases the **D5** input of the shift register is grounded, to Vss.
6. Bit 12 **s_clk_o<8>** is disabled.
7. Bit 11 **s_clk_o<7>** is disabled.
8. Bit 10 **s_clk_o<6>** is disabled.
9. Bit 9 **s_clk_o<5>** is disabled.
