21154 PCI-to-PCI Bridge

Specification Update

July 2004

Order Number: [278295-017](#)

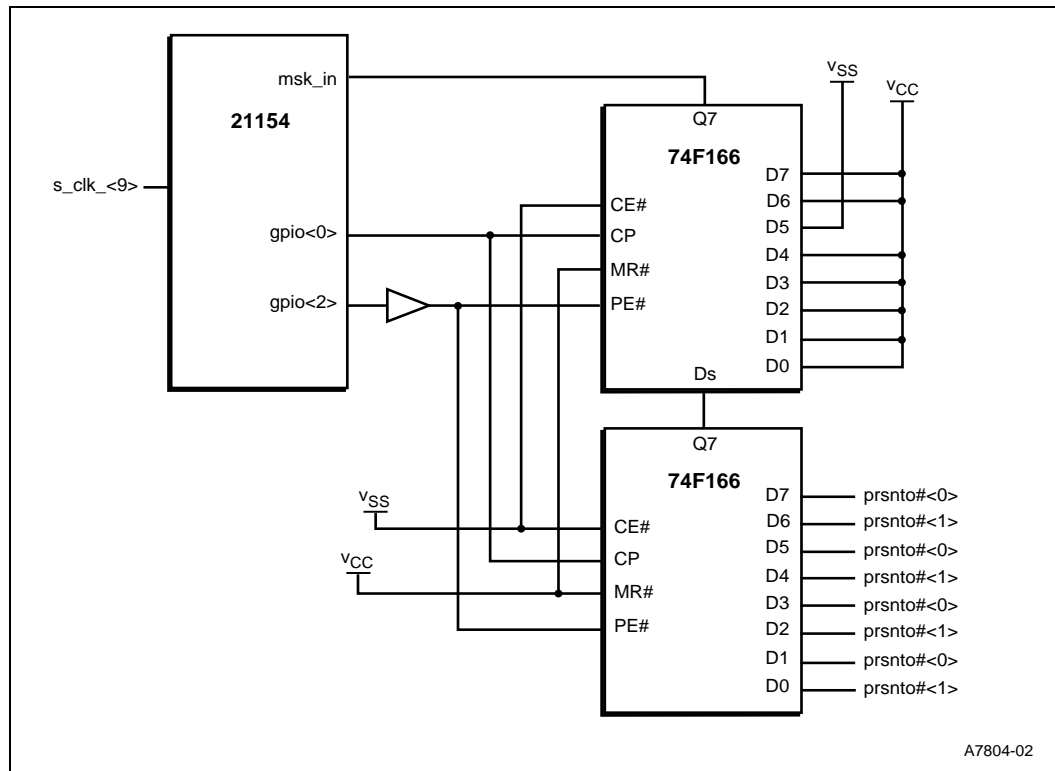
Figure 3 Example of GPIO Clock Mask Implementation on the System Board

18. Section 4.4.1, Serial Clock Mask Shift, Figure 3

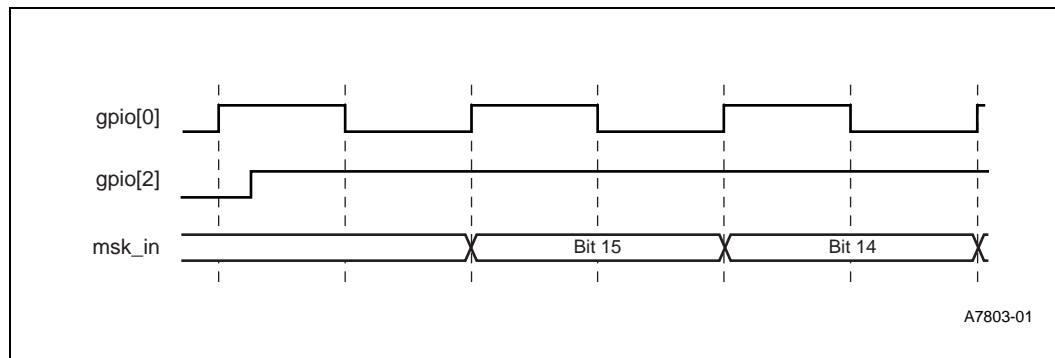
Figure 4. Clock Mask Load and Shift Timing

19. Section 4.4.1, Serial Clock Mask Shift, Figure 4
