Errata Sheet

March 30, 2001 / Release 1.0

Device: SAB-C165-LM, -LF
SAF-C165-LM, -LF
SAB-C165-L25M, -L25F
SAF-C165-L25M, -L25F
SAB-C165-LM3V, -LF3V
SAF-C165-LM3V, -LF3V

Stepping Code / Marking: ES-HA, HA

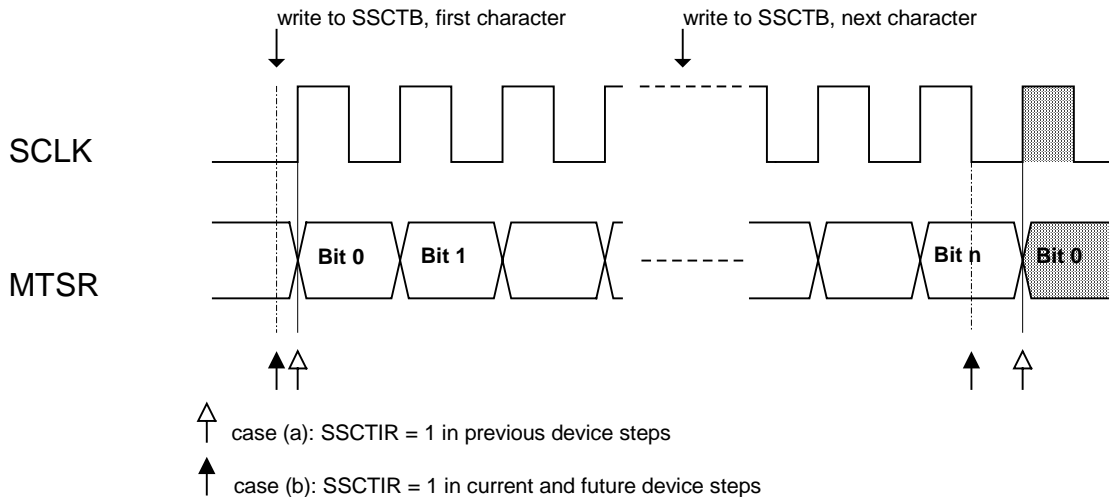
The following diagram shows these relations in an example for a data transfer in master mode with SSCPO = 0 and SSCPH = 0. It is assumed that the transmit shift register is empty at the time the first character is written to SSCTB:

- (b) beginning with step **FA** (internal stepping F12) of the **C165**, when SSCTB has been written while the transmit shift register was empty (and the SSC is enabled), flag SSCTIR is set to '1' directly after completion of the write operation, independent of the selected baud rate. When the transmit shift register is not empty when SSCTB was written, SSCTIR is set to '1' after the last latching edge of SCLK (= 1/2 bit time before the first shifting edge of the next character). See also e.g. C167CR User's Manual V3.1, p. 12-5.

Typically, in interrupt driven systems, no problems are expected from the modified timing of flag SSCTIR. However, when flag SSCTIR is polled by software in combination with other flags which are set/cleared at the end or at the beginning of a transfer (e.g. SSCBSY), the modified timing may have an effect.
